**Upcoming Work  
at  
Buildings 386/388**

**Investigation Area C2**

Presented to  
Mare Island Restoration Advisory Board  
September 24, 2020

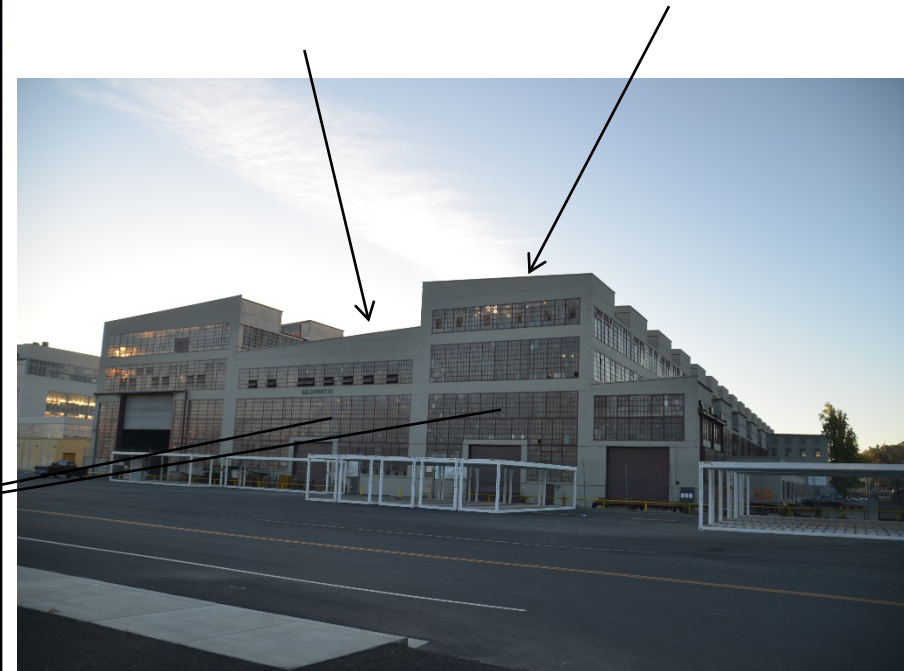
View is Across Bagley Street  
to the Southeast

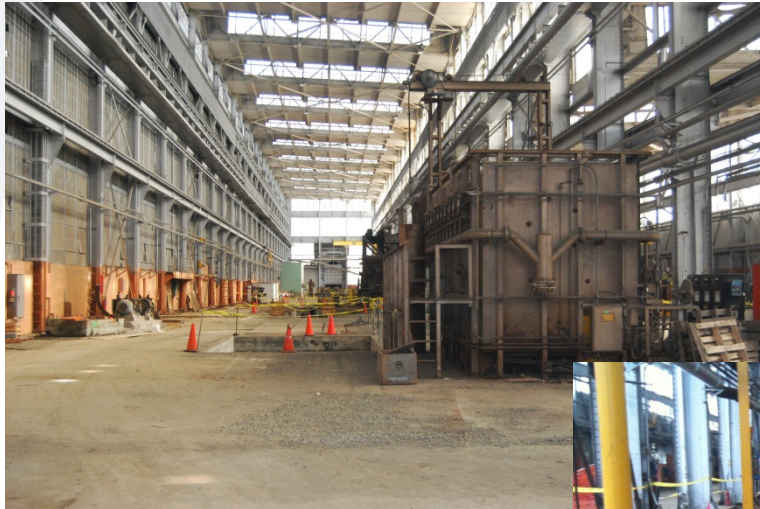
**Building 386 - Interior  
View to the South  
(Prior to  
Equipment Removal)**

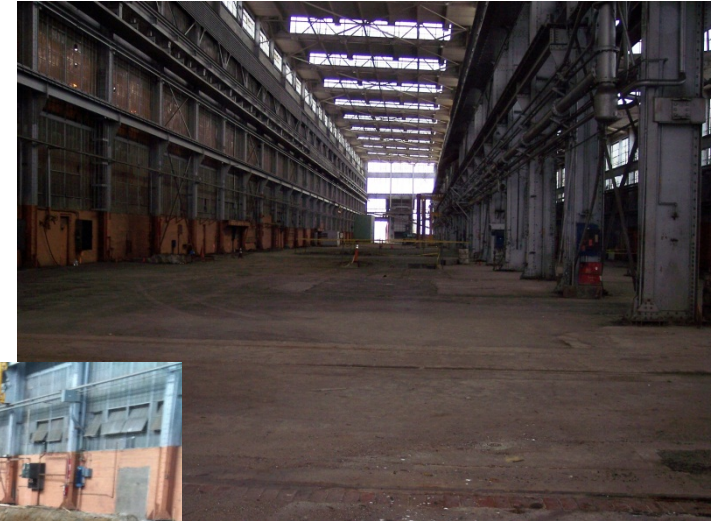
**Building 386 - Interior  
View to the South  
(Following Equipment  
Removal and  
Remediation)**

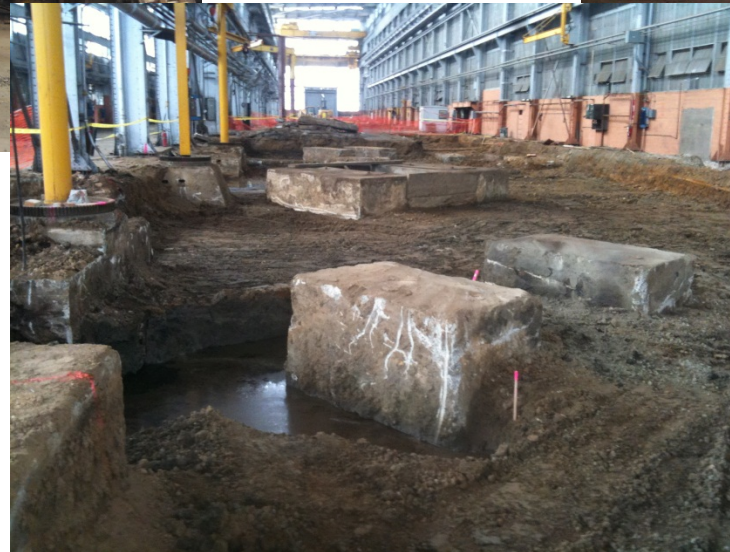
**Building 386 - Interior View to the North –  
During Remediation (Southern Dirt Area)**

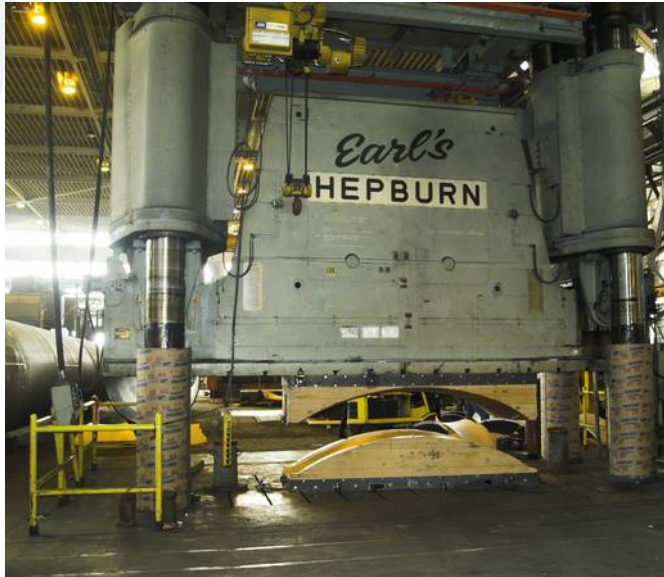
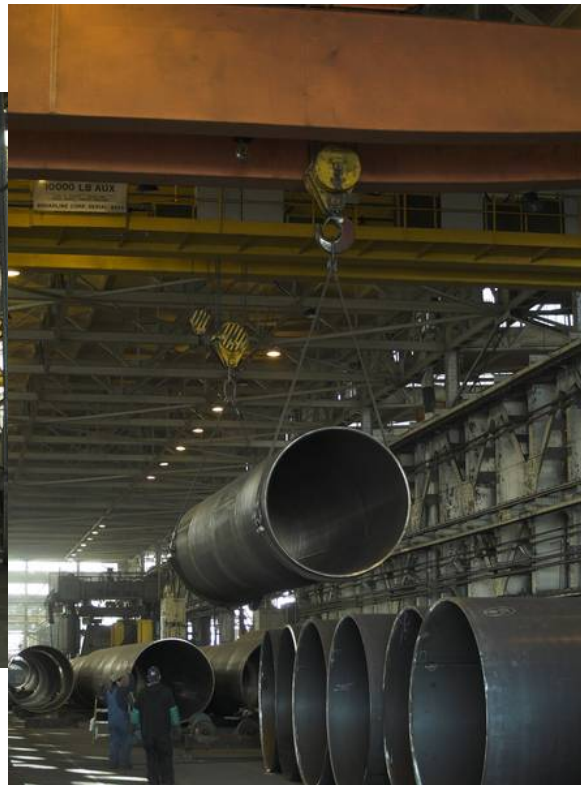
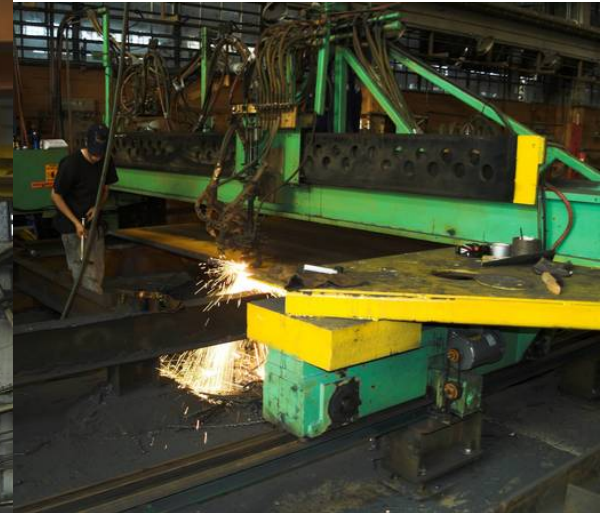
**Building 388 - Interior Views of  
Equipment and Products**

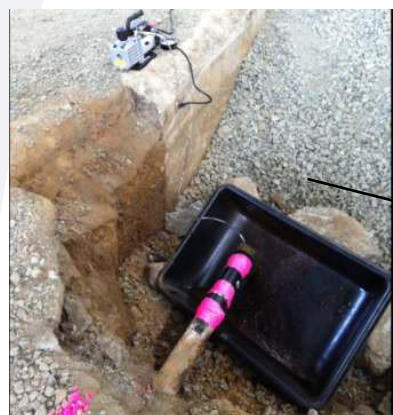
Pipeline Vacuum Test

- ❖ Vacuum Tested Bad Condition Pipelines
    - ❖ Flushed (Non-Phosphate Detergent) Oil Pipeline Segments Containing Free-Phase Liquids
    - ❖ Collected Rinsate Samples from Flushed Pipelines and Analyzed for Petroleum Hydrocarbons

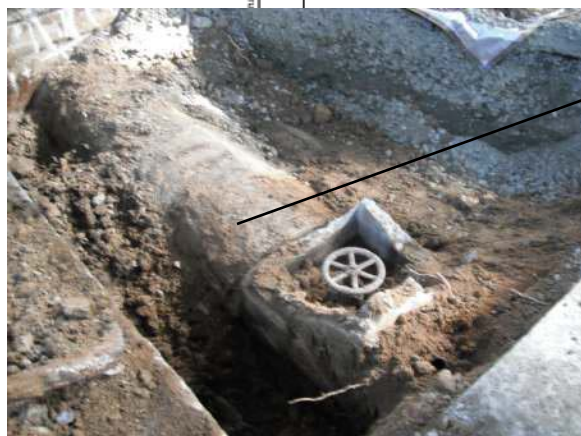
Previously Unknown Underground Structure

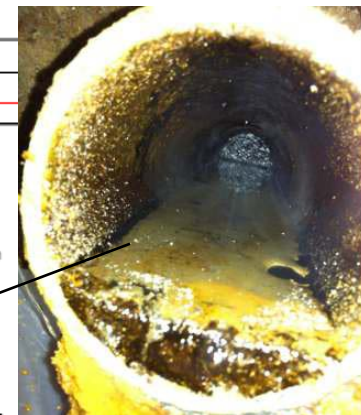
Oil in Pipeline

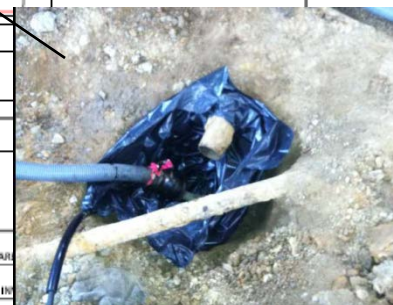
Draining Oil in Pipeline

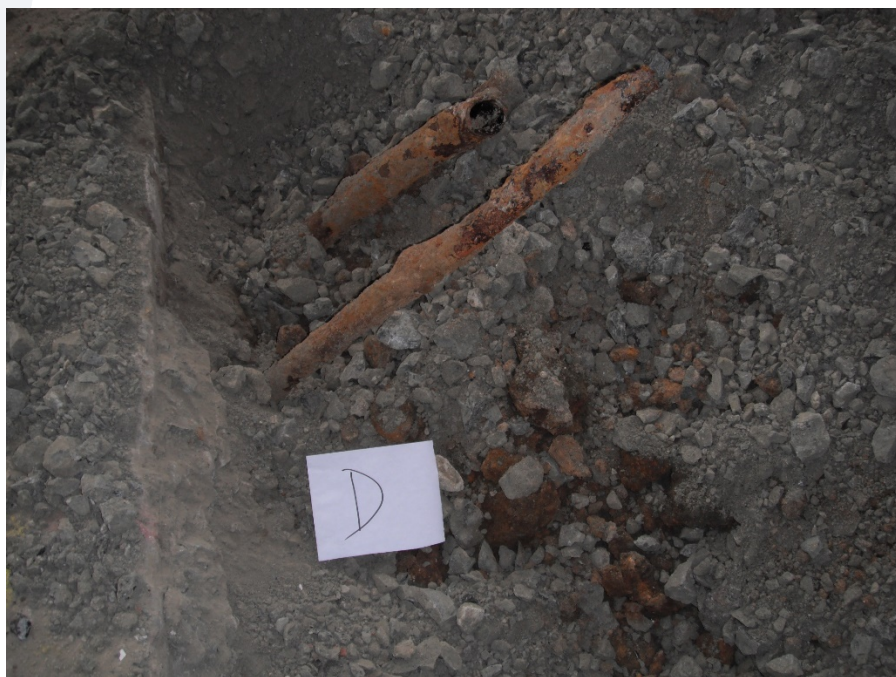
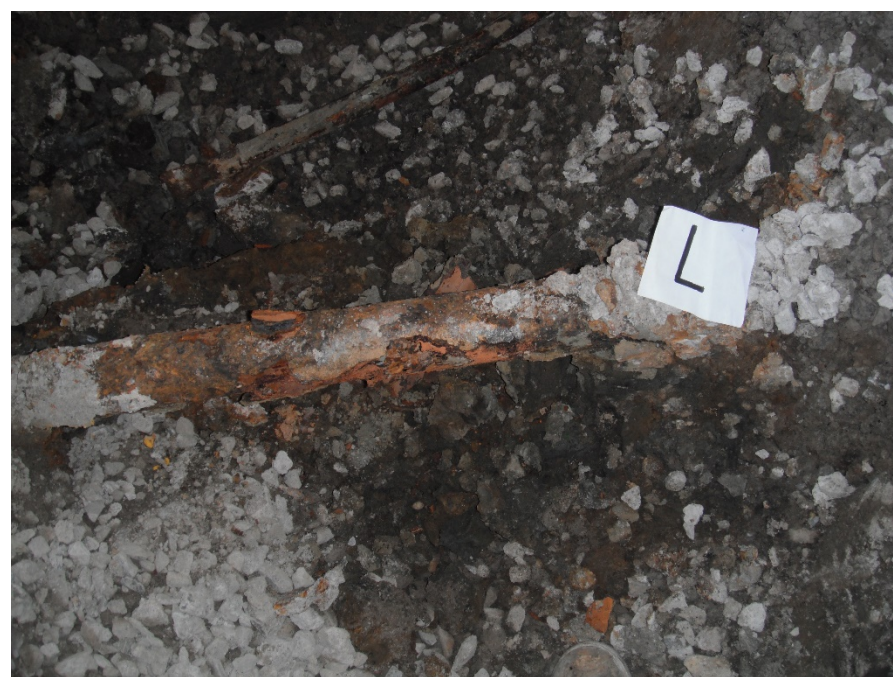
**Pipelines in  
Poor Condition**

- ❖ Sealed Ends of Pipelines that Appeared to be in Good Condition
    - ❖ Remove Pipelines that Appeared to be in Bad Condition
  - **Underground Oil Pipeline Investigations and Remedial Activities (2013-2014)**

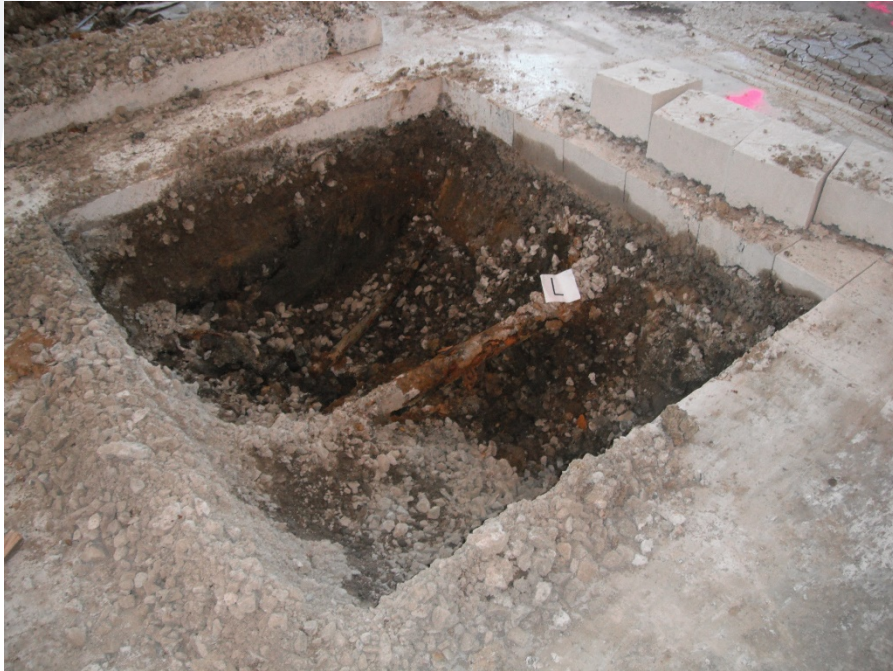
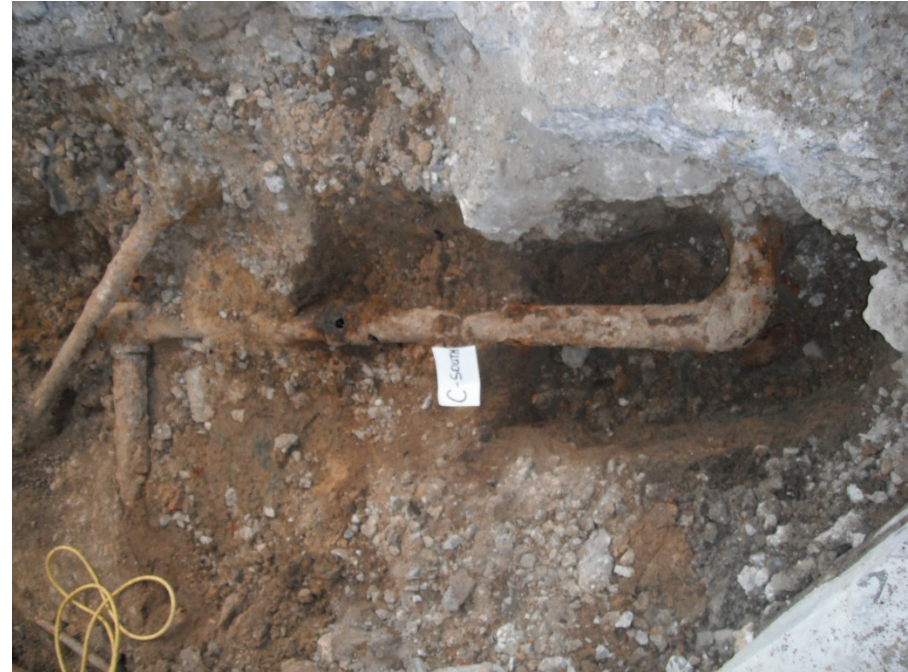
**Pipelines in  
Poor Condition**

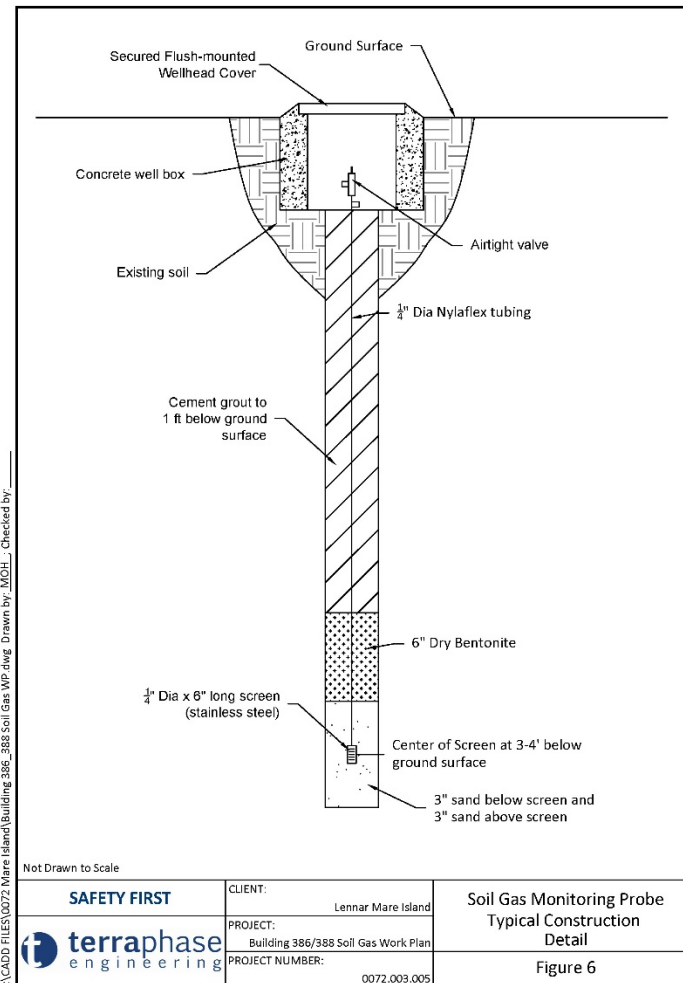
## Soil Gas Monitoring Probe Construction Detail

- ❖ Points to be Installed to a Maximum Depth of 4 feet bgs
